# Multi-Family Hot Water Temperature Maintenance Study

30 June 2017

Prepared for  
Robert Weber, Project Manager  
Bonneville Power Administration

Prepared by  
Jonathan Heller, Shawn Oram, Gia Mugford, Michael Logsdon, and Ben Larson  
Ecotope, Inc.

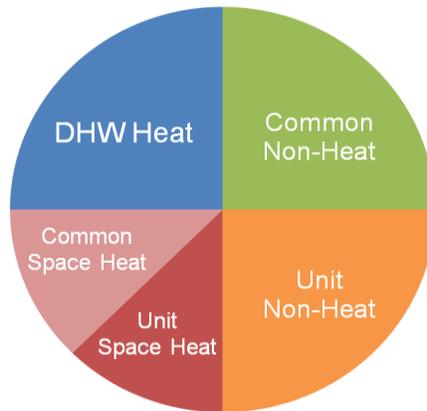
**Figure 3. Energy End Use Breakdown for new Multifamily Buildings in Seattle (Heller 2009)**

Recent research of energy use in a sample of ten new construction Seattle buildings indicates that domestic water heating likewise accounts for about 25% of the energy use of a typical Seattle apartment building (Heller 2009). The median energy use intensity observed for the buildings was 39 kBtu/ft<sup>2</sup> per year meaning site energy used for water heating was 10 kBtu/ft<sup>2</sup> per year alone. While heating and cooling loads vary significantly by climate, domestic water heating loads are driven by fixture flow rates and occupant behavior. Therefore, we expect hot water needs to be similar across the Pacific Northwest if fixtures and occupant behaviors are comparable.

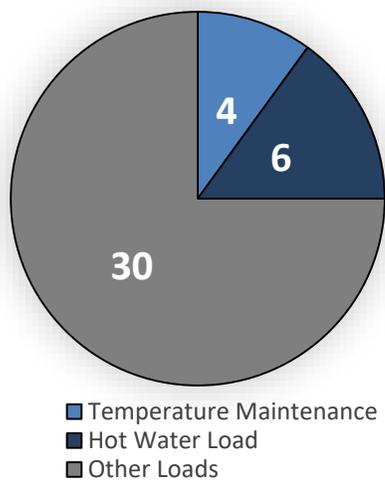
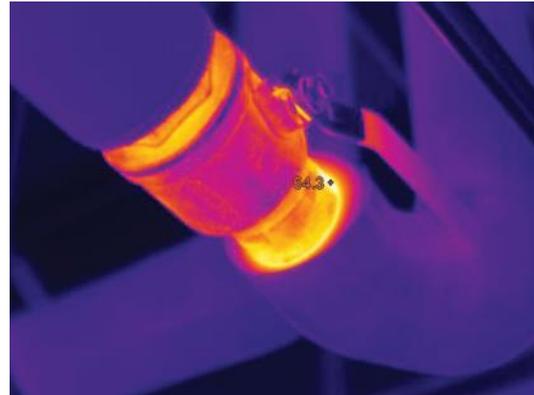
**Figure 4. Temperature Maintenance Energy Use (Btu/ft<sup>2</sup>/yr) And Typical Heat Loss Source**

Previous research to support the adoption of reverse cycle chillers (RCC otherwise known as air-source heat pumps) in larger multifamily apartments involved estimation of the efficiency of the systems as a whole (Heller 2015). Results indicated that while the heat pump equipment functioned reasonably well, the overall performance of the system was not as high as expected. These observations revealed that temperature maintenance losses from traditional recirculation systems were greater than current assumptions of 20%. The systems monitored at two new construction midrise apartment buildings (92 and 118 units, respectively) indicated maintenance losses of approximately 40% of the water heating load. This is equivalent to 10% of all the energy used on site. Figure 4 illustrates the proportion of the energy used and, in the left infrared photo, shows a typical source of heat loss: an uninsulated valve on the distribution piping.

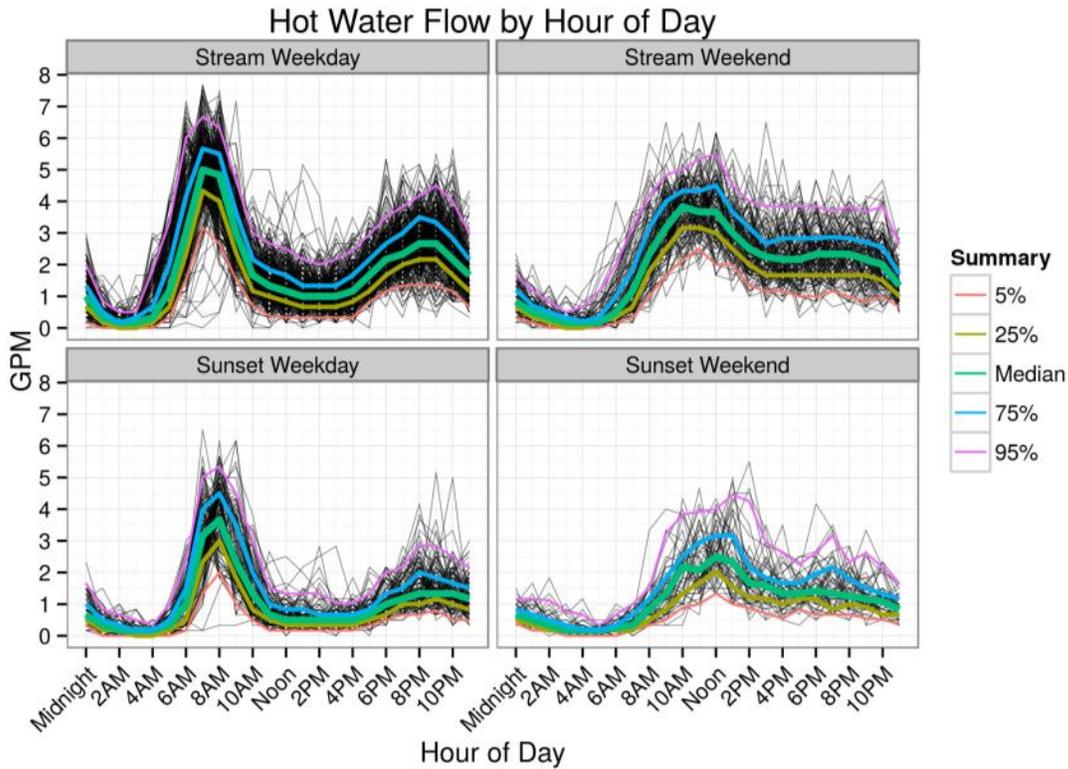
Figure 5. Hourly Hot Water Use in two ~100 Unit Multifamily Buildings

As part of the previous RCC research, hot water withdrawals from apartment central water heating systems were monitored. With a large number of apartments, and residents bathing and washing on differing schedules, water withdrawals happened throughout the day and night (see Figure 5). This meant that there were few if any periods when turning off the circulation pump would not result in delays in delivery of hot water. Even in the 2-4am hours, there were very few times when someone in the building wasn't using water every hour. This constant use means there is no opportunity to allow the temperature in pipes to drop. The result is a need for temperature maintenance twenty-four hours per day.

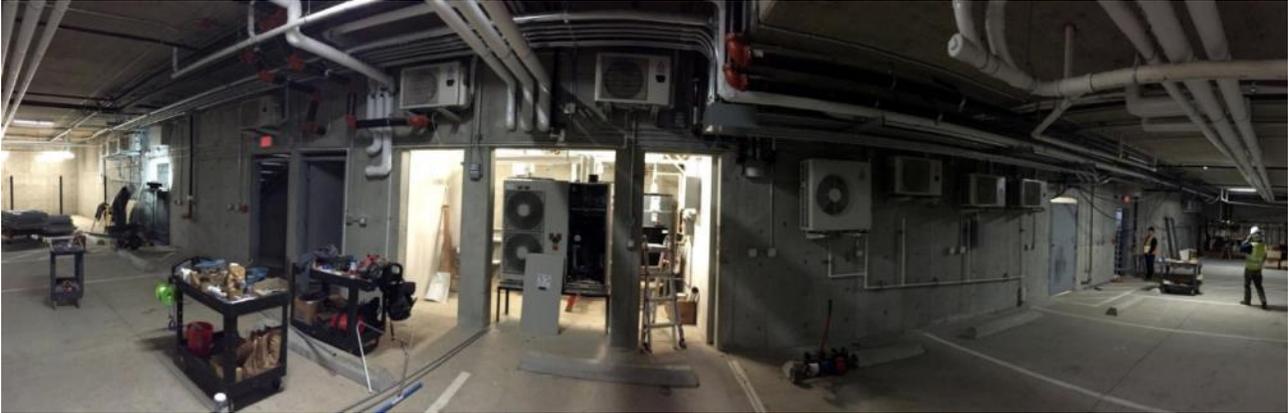
**Figure 6. Altherma Monobloc Heat Pumps in Parking Garage**

The heat pump compressors were installed in open mechanical bays in the parking garages. Figure 6 shows the Altherma heat pumps in the center. Other mini-split heat pumps for apartment space heating can be seen mounted to the walls. When used for summertime cooling, these units dump heat to the garage which can be harvested by the water heating system. Storage tanks were located behind the heat pumps, in the unconditioned space of the garage. The tanks were not insulated over code required levels. Figure 7 shows the hot water tanks on the right and the back of the Altherma unit on the left.

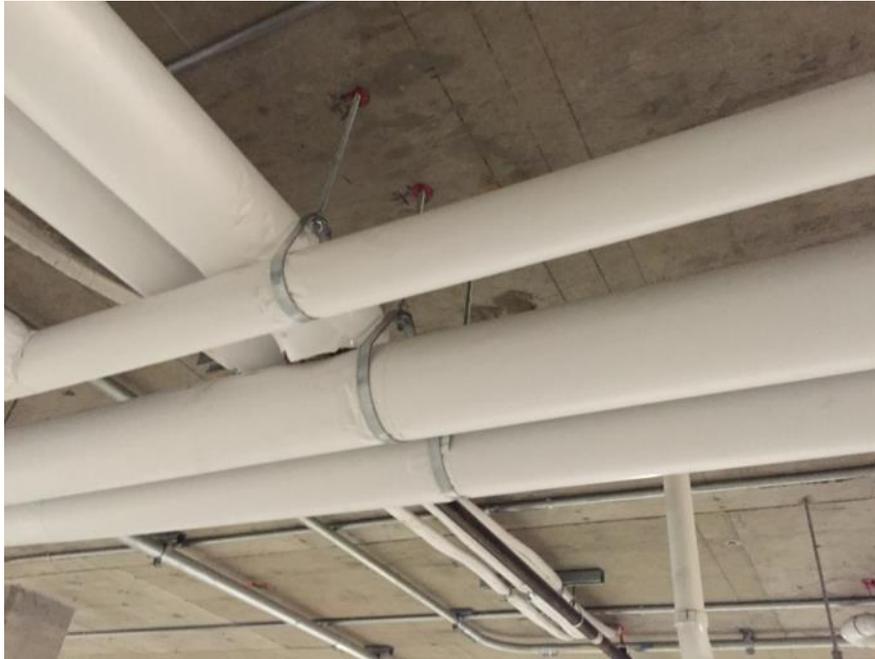
**Figure 8. Pipe Insulated without Thermal Bridging**

The water distribution pipes were insulated in excess of 2012 Washington State Energy Code requirements. In the parking garage, all exposed piping was insulated with two inches of pipe wrap. Contractors used best practices as pictured in Figure 8. The pipe hangers were installed outside the insulation to prevent conductive thermal bridging.

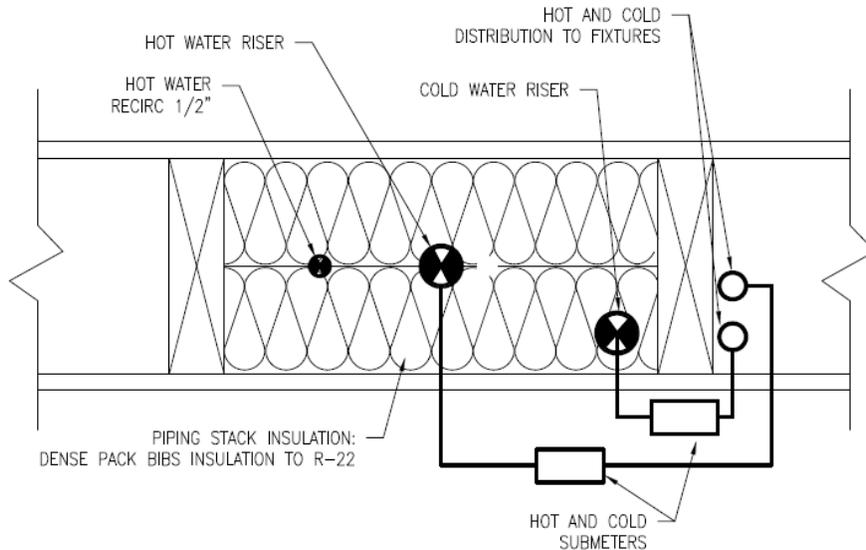
**Figure 9. Typical Cavity Insulation Detail**

The hot water risers were installed in wall cavities which were themselves insulated (Figure 9). The pipes ran through the middle of a double 2x4 wall and the cavity was dense packed with insulation resulting in R-11 encasing the pipes. Once in the units (the final leg of the piping), and hence beyond the purview of the circulation loop, the pipes were uninsulated.

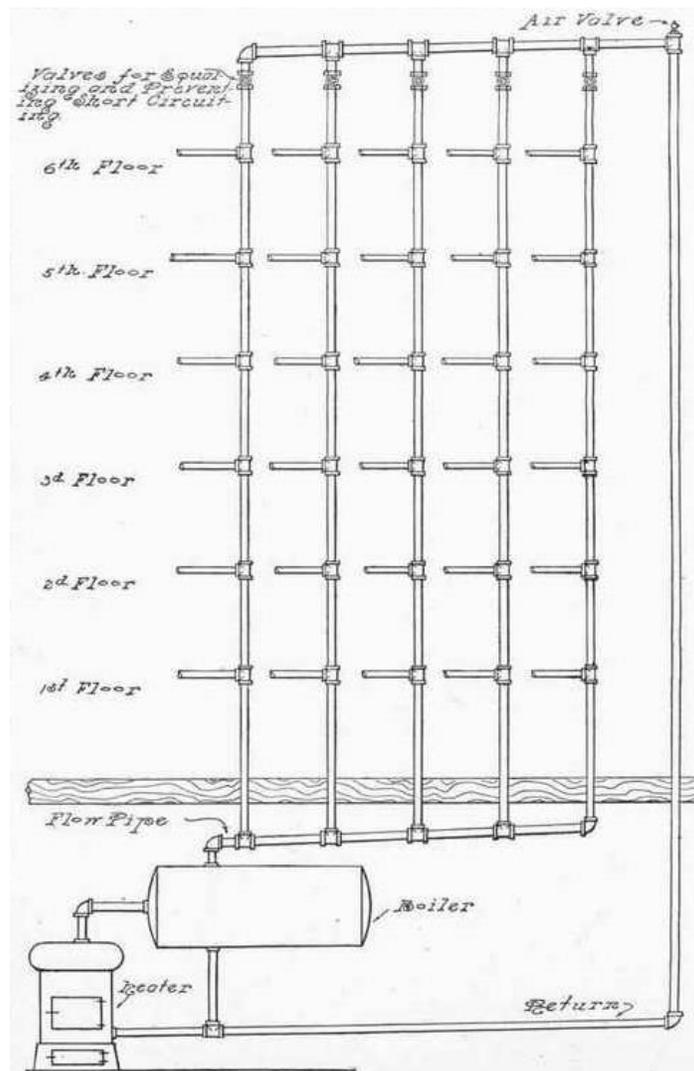
Figure 10. Traditional Temperature Maintenance Strategy

The traditional recirculation system uses a pump to move water in a loop from the central storage tank, past branch pipes for every unit, and back to the central tank. The branch pipes are not continuously flushed with hot water but are short enough that they quickly empty of cool water when occupants open fixtures. Once water is heated, it losses heat constantly until it leaves the building (well, it keeps cooling off to surrounding temperatures then too). Heat losses occur in the storage tank and more acutely in the circulation system. Heat loss is simply a function of insulation and surface area. The more circulation pipe, the more heat loss. Typically, water may be supplied to the loop at 125F and pump flow rates set so the water returns ten degrees cooler. Figure 10 illustrates a traditional system lay out.

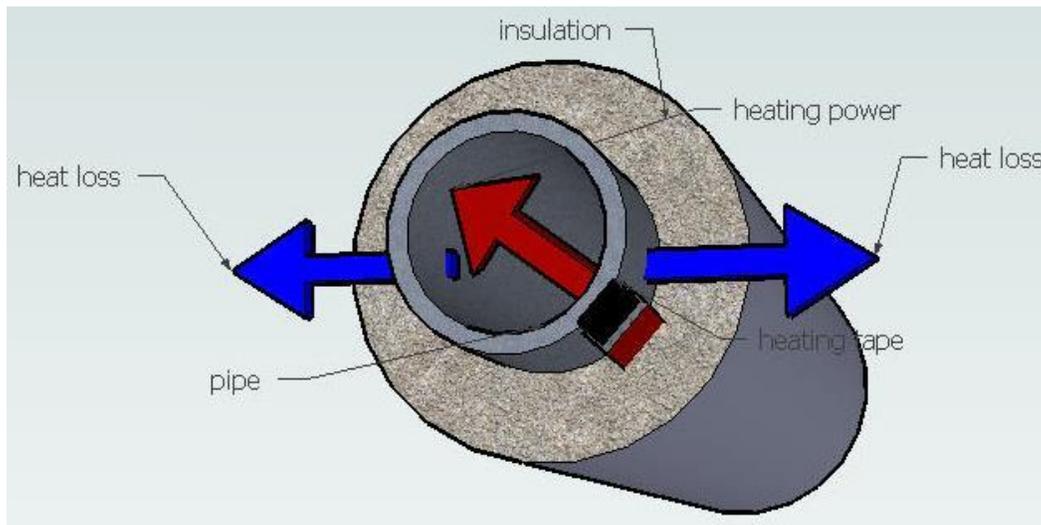
**Figure 11. Temperature Maintenance With Heat Trace**

freezing in unheated locations. Figure 11 demonstrates how heat trace is installed on the water pipe between the pipe and the pipe insulation. A thermostatic controller is set to maintain the desired temperature in the piping. For good heat transfer, conductive piping should be used with the heat trace. Heat trace systems have a limited lifespan and will potentially need replacement within the life of the building. For this reason the heat trace should be placed in areas that can be easily accessed to allow for future replacement.

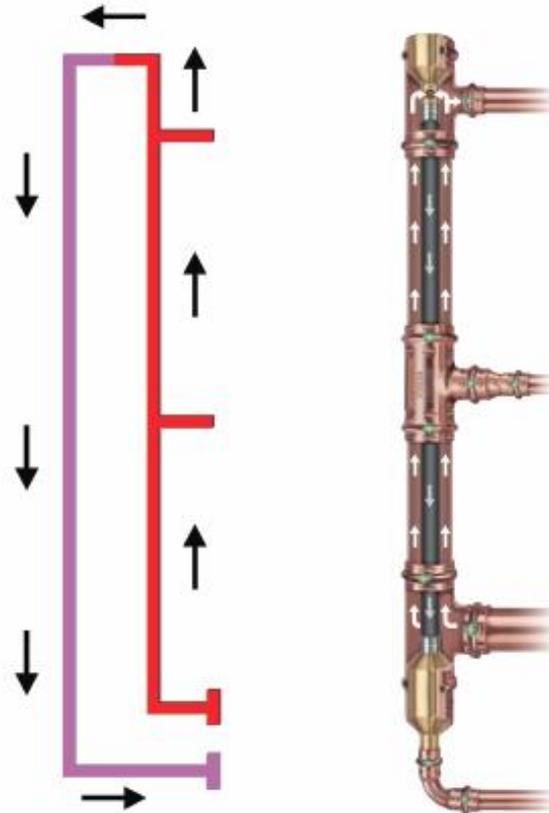
Figure 12. Pipe in a Pipe Temperature Maintenance System at right. Conventional at left.

To reduce the losses from recirculation, distribution alternatives such as the pipe in pipe system have been designed. The plumbing design is similar to traditional hot water circulation, except that the return piping is located inside of the supply riser. Figure 12 illustrates the configuration. Two concentric pipes are used. Water is supplied on the exterior and returned through the interior. In effect, this design insulates the return water from the surrounding building (it would actually heat it slightly). Overall, this reduces the heat loss rate of the distribution system although it does not cut it in half because larger diameter pipe is needed for this system. Pipe surface area, and heat loss, increases proportional to the natural log of the radius. So, the pipe run is half but surface area is more than half. Still, it is a significant reduction in area.

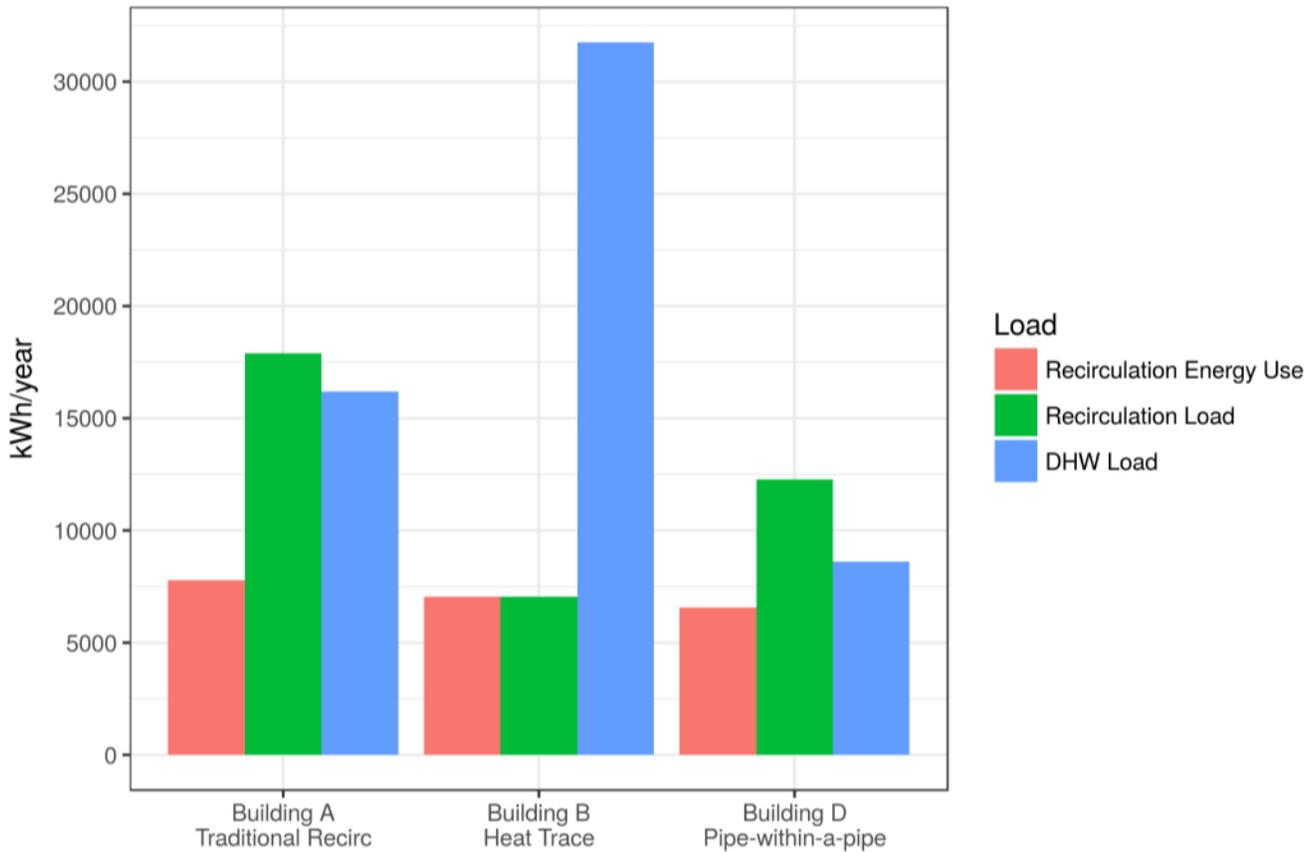
Figure 13. Measured Annual Energy Use

Figure 13 visualizes the energy use findings of DHW load, recirculation load, and the energy input expended to meet the recirculation load. This figure makes plain the large discrepancy in hot water demand, which confounded the ideal comparison between sites. As expected, the traditional recirculation scheme resulted in the highest temperature maintenance load. Somewhat surprising was how much higher the pipe-within-a-pipe load was than the heat trace load. We had expected them to be closer. The chart shows that, in the case of sites A and D with recirculation loops, the maintenance load was larger yet met with heat pump COP. At site B, the maintenance load was smaller but met with an electric resistance COP of 1. Despite the varying magnitudes of temperature maintenance load, the estimated energy use spent meeting the load turned out remarkably similar. We estimate annual energy use for temperature maintenance as 7800, 7000, and 6600 kWh per year respectively for Building A, B, and D. (The estimate for Building D reflects equipment problems encountered at that site, and under ideal system operation the pipe-within-a-pipe energy use for temperature maintenance could be as low as 5600 kWh per year.) The relative closeness of these numbers suggests that the optimal strategy may also rely crucially on the manner in which the temperature maintenance strategy interacts with heat pump operation and system controls. This will be discussed further in the report.

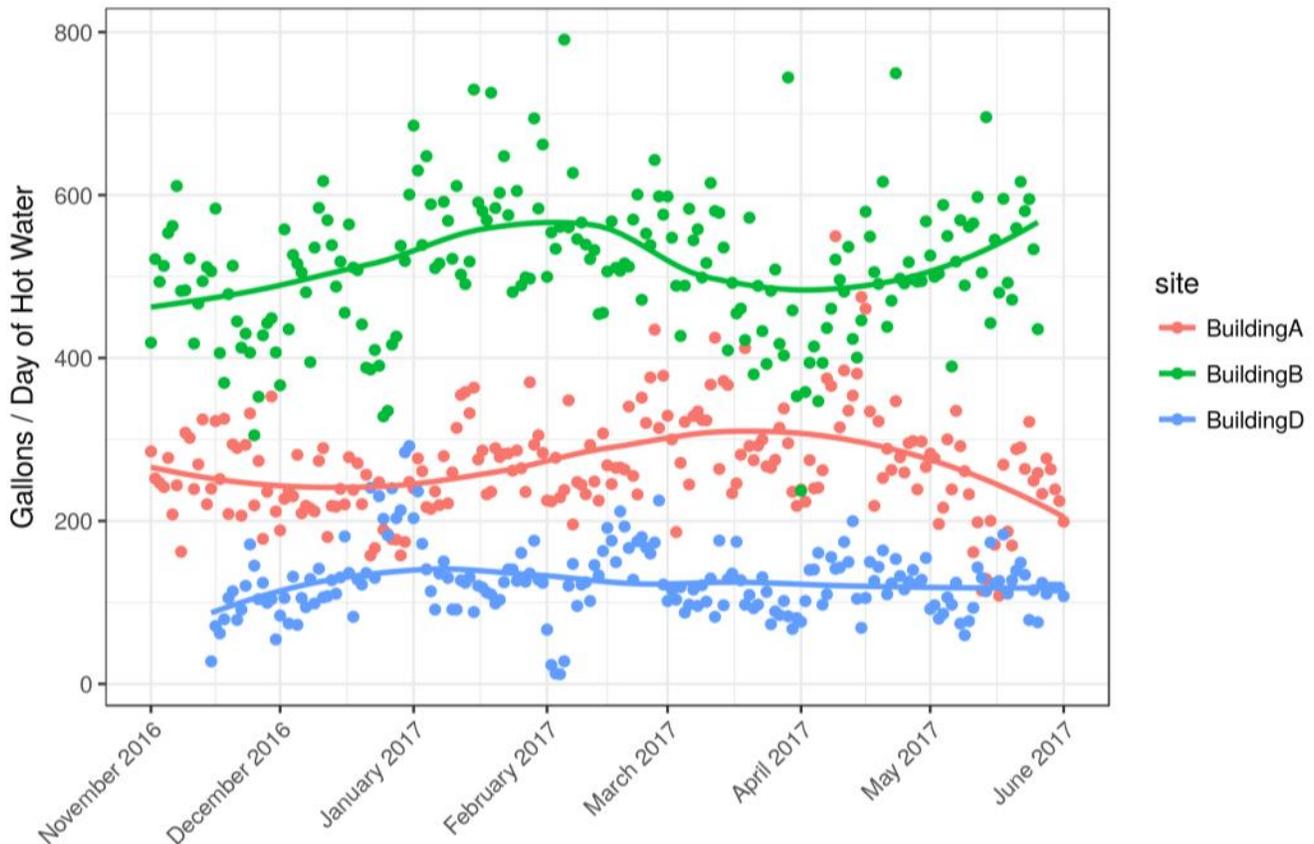
Figure 14. Daily Hot Water Demand

Figure 14 shows the daily hot water demand over 7 months of the study. The expected shape is to have a peak in February and a trough in July/August corresponding to the coldest and hottest inlet cold water temperatures. That did not reveal itself in these buildings potentially due to irregular occupancy (snow birds) or the buildings not being completely leased for the period graphed.

Hot water use is an important factor in determining the heat pump efficiency and the amount of energy spent on temperature maintenance. Greater overall hot water use should improve both – a higher heat pump COP and lower maintenance energy requirements. The fact that total water usage differed by a factor of three between buildings confounded some of the subsequent performance comparisons in ways that are not quantifiable. We simply have no way to answer the question: what if the occupants of Building B had used 100 gallons per day instead of 500? How would that have affected the operation of the variable speed heat pump system with heat trace temperature maintenance? The qualitative aspects of the differences described previously, however, should be kept in mind when interpreting the findings.

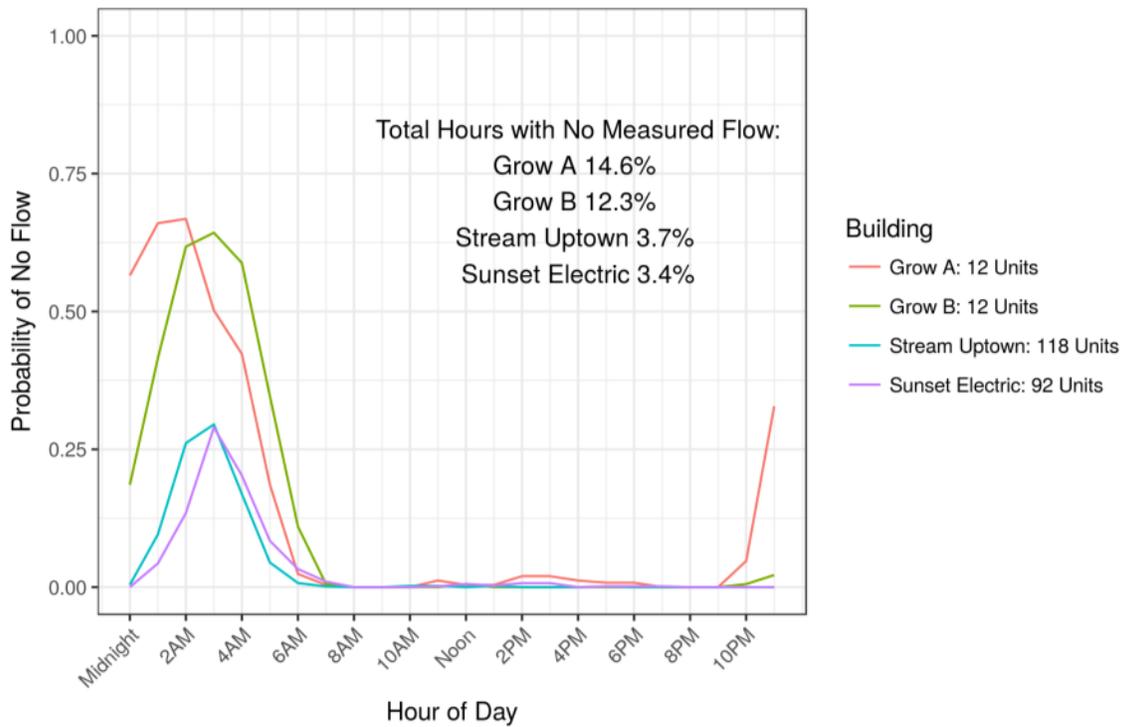
**Figure 15. Chance of No Hot Water Use**

Figure 15 displays the chance of no hot water being used in a building for a given hour of the day. The data were based on Buildings A and B from this project and two larger mid-rise buildings recently constructed and monitored in Seattle (the pilot buildings for the RCC project). The graph highlights the need for constant temperature maintenance – that is to say, continuously operating circulation pumps or heat trace. The graphs can be interpreted as follows: between 1am and 4am there was a  $\frac{2}{3}$  chance that no one in the Grow buildings would have needed hot water during that hour. Those sound like pretty high odds but, examined another way, it means that every one out of three nights, someone wanted hot water at 3am. This is simply too frequent to turn the temperature maintenance off and not provide hot water in a timely fashion. Surprisingly, this usage requirement was in a building as small as twelve units. For larger buildings, like the two mid-rise cases, the no-usage window was narrower and peaked at only a  $\frac{1}{4}$  chance. The hot water demand monitoring at these buildings suggested limited potential for opportunistically disabling the temperature maintenance system.

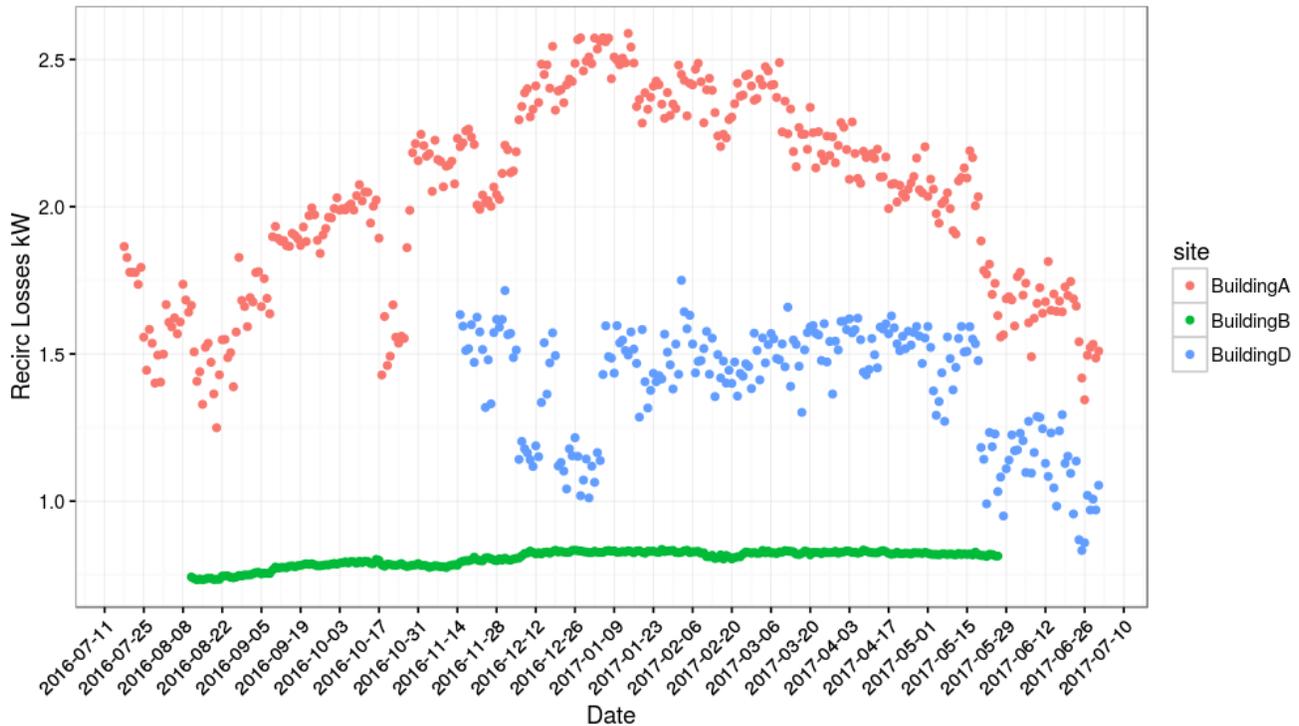
Figure 16. Temperature Maintenance Load

Hot water maintenance losses averaged 2.1kW at Building A and ranged from 1.5 kW in the summer to 2.5 kW in the winter. Figure 16 depicts the seasonal trend and the maintenance loads at all the buildings. The energy use is clearly correlated with garage and outdoor air temperature. Building B, with heat trace, showed a persistent 0.8kW load with, perhaps a mild upward trend in the colder months. At Building D, a 1.4kW load, there is no obvious seasonal effect. Some seasonality is to be expected, as the garage temperature varied with season and all systems contained piping in the parking garage. With 120F delivered water temperature, 40F wintertime garage air temperature, and 70F summertime garage temperature, one would expect the losses occurring in the garage to increase by 60% with the remaining losses mostly unchanged. Oddly, the overall maintenance losses at A increased by 60% between summer and winter, which seems erroneously high. Further, it is not clear why the other buildings showed no seasonality. The discrepancy could be due to incorrect temperature measurements or differences in water temperature delivered to the taps. It is possible that the water temperature delivered to apartment fixtures varied seasonally, although within a narrow enough range to obviate occupant complaints. Even under suspicion of the measured maintenance losses, though, the three systems at least ranked in the correct order, with traditional recirculation showing the highest losses, heat traces the lowest, and pipe-within-a-pipe intermediate.

Also note that the interval in late 2016 where the maintenance losses at D dropped to 1.1 kW occurred due to an equipment malfunction that dropped the delivered water temperature approximately 4F compared to normal.

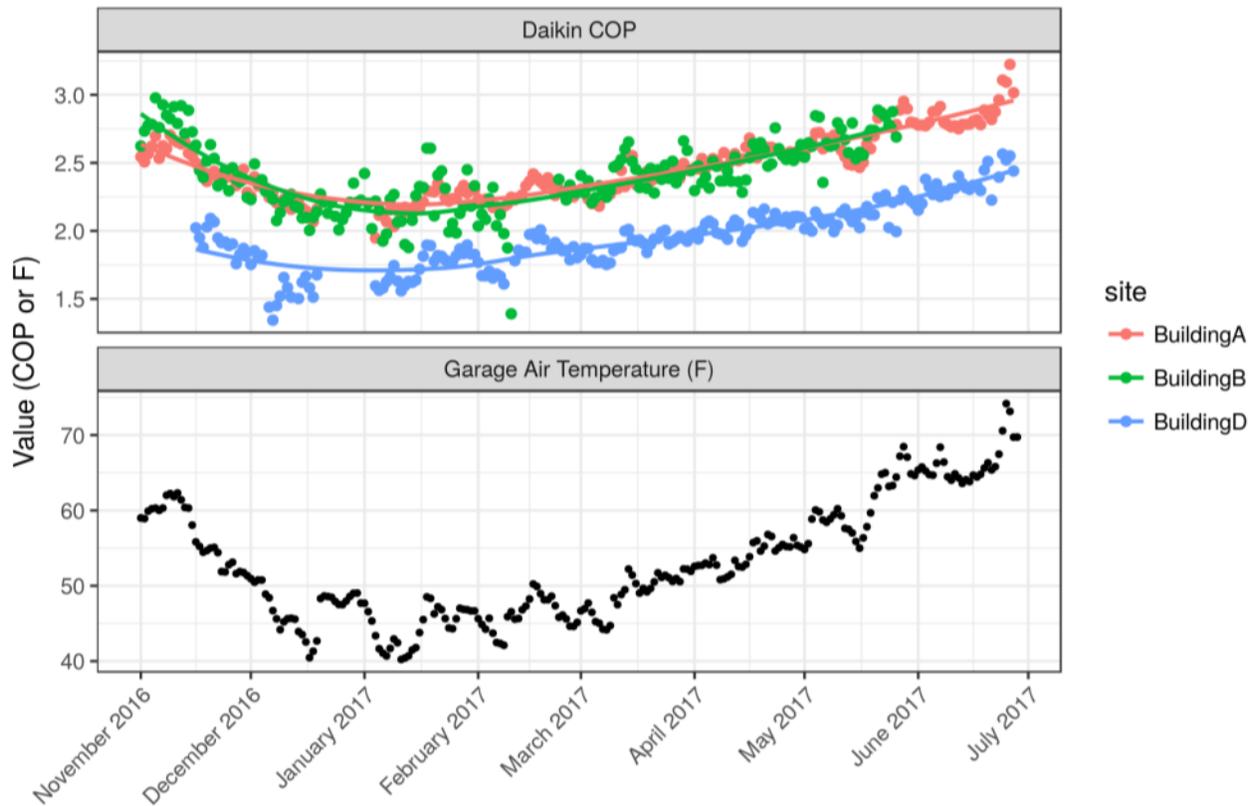
**Figure 17. Daily Heat Pump COP and Garage Air Temperature**

The expected seasonal trend of heat pump performance is revealed in Figure 17. All the heat pump “outdoor” units are located in the subterranean parking garage. Those for Buildings A and B are deep within the garage while Building D’s heat pump is close to the garage entrance. This proximity creates more direct, unmoderated air exchange with the outside. Monitoring of air temperatures at the system intake indicated that temperatures were both lower and more variable for Building D’s system during the study. Still, that doesn’t explain the consistently 0.5 COP point lower value. In the summer months, one would expect its COP to be higher because it would be exposed to warmer air. Monitoring in July, August, and September may reveal as much. A major source for the lower COP, asynchronous component operation, is explained in section 3.5.1

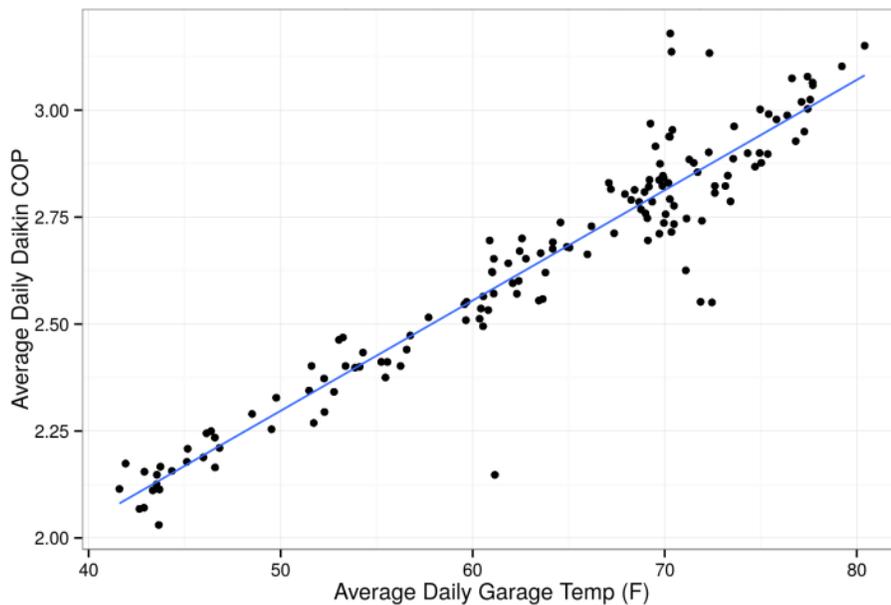
**Figure 18. Building A Altherma COP vs Garage Temperature**

It is also useful to know the equipment COP as a direct function of the source air temperature which, in this case, is the garage air. Figure 18 plots average daily COP for Altherma A against average daily garage air temperature. The data are remarkably linear.

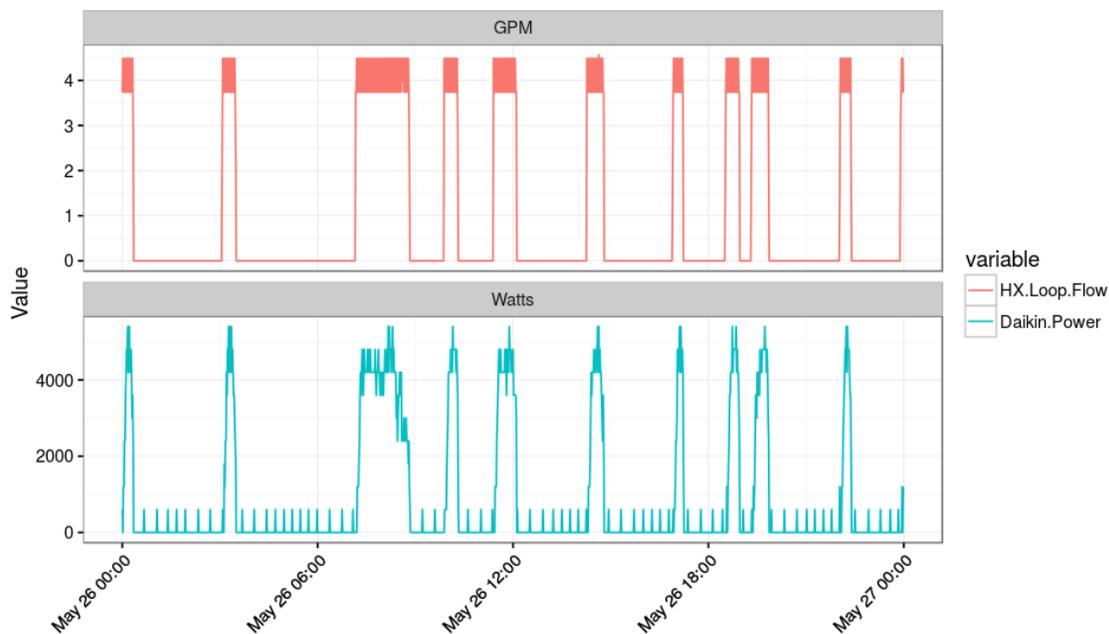
**Figure 19. Ideal, Synchronized Operation at Building B**

The heat pumps in buildings A and B performed consistently after start up, with similar equipment COPs in response to temperatures of source air. Communication interaction failures between the aquastat, switching relay, and Altherma unit occurred in all the installations. Ecotope made numerous site visits, including some with a Daikin assigned Altherma expert, to adjust settings throughout the system. Figure 19 shows ideal operation, after optimization efforts at Building B. The Daikin Altherma and the heat exchanger loop flow in lockstep as directed by the switching relay. The figure also shows extended runtimes in the morning extremely typical of the hot water use patterns in these buildings.

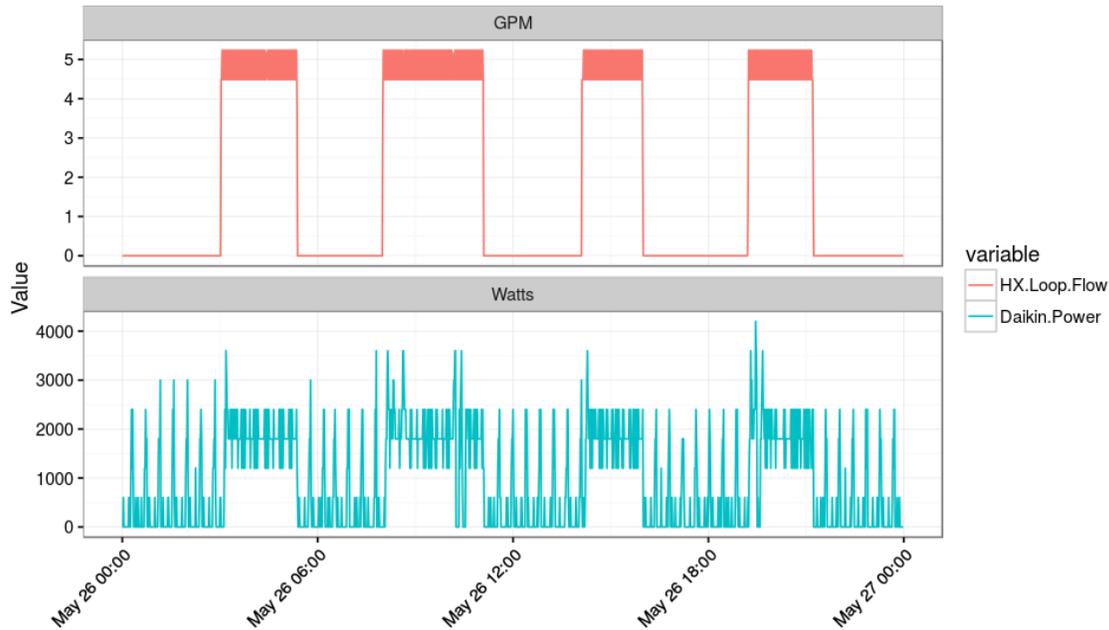
Figure 20. Problematic, Asynchronous Operation at Building D

In contrast, the system at Building D experienced ongoing difficulty in interactions between the Altherma operation and heat exchanger loop pump operation. Ideally, they run in sync but this was never achieved in the project. Figure 20 shows the problematic operation where the Altherma is on when it doesn't need to be. This resulted in hot water looping repeatedly through the heat exchanger on the Altherma side without the heat then being moved on to the storage tanks. The behavior reduced the efficiency of the system, employing the heat exchanger to work on water which was not in need of input heat. Repeated attempts to synchronize the behavior of the Altherma with the water pump were not successful. Strategies used to solve the same problems at Buildings A and B did not work at D. Likely, the issue is within the control logic of the Altherma and the inability of the switching relay to override it.

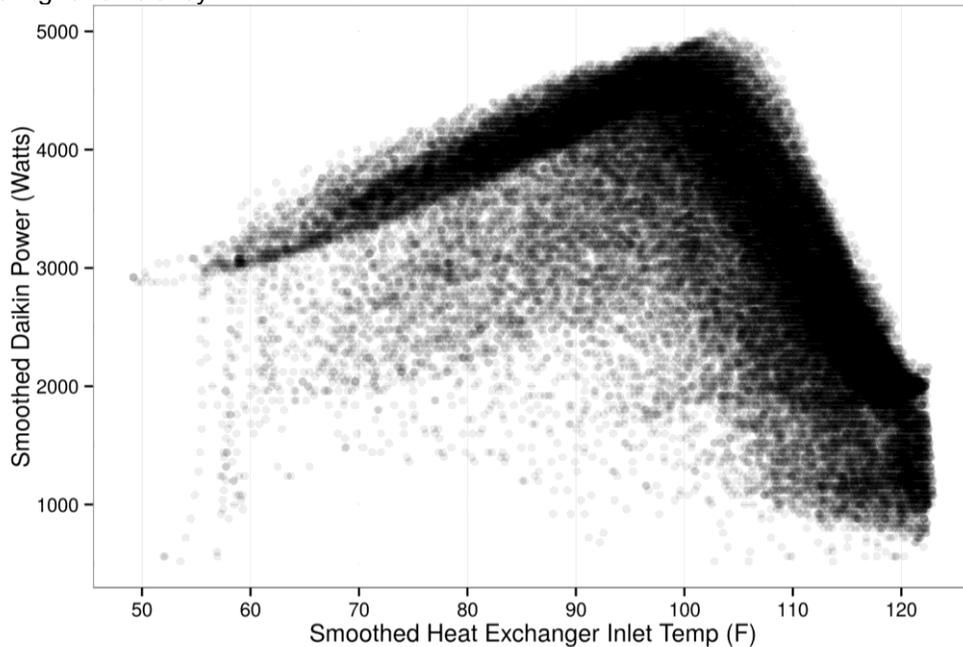
**Figure 21. Building B Daikin Power by Heat Exchanger Inlet Temperature**

Variable speed heat pumps can operate at higher efficiencies under “part-load.” The heat pump has a fixed outdoor unit heat exchanger size (in this case, the evaporator). When operating at a fraction of the maximum speed, the heat exchange is effectively larger, relatively to the load, than it is when the heat pump operates at maximum speed. The larger heat exchanger allows for more heat to be absorbed from the air at a lower work load and, hence, the higher efficiency.

While not a conclusive result, we suspect that the lack of an efficiency boost at the heat trace site may have derived from the variable speed logic of the Altherma in this particular design. See Figure 21. While the Althermas at Buildings A and D – working constantly against 120F water from the well-mixed tanks – ran almost exclusively around the minimum input power of 2kW, the Building B unit regularly ramped up to as much as 5kW in response to colder water temperatures. It may have been that the Altherma responded to cooler water temperatures with the utmost urgency, sacrificing efficiency in the name of heating expediency. This is suggested by the sort of boomerang shape as in Figure 21, where power increased with inlet temperature to a maximum of 5kW at 100F, before declining to 2kW at 120F. In the NEEA lab testing of an analogous single-family-sized Daikin, no such boomerang shape occurred. Power increased approximately linearly to the upper temperature limit of the equipment. This sort of behavior was not observed at Buildings A and D because the inlet water rarely strayed from around 120F.

Although by no means a rigorously confirmed result, this is our best explanation as to why heat pump efficiency at Building B unexpectedly failed to outperform the recirculation-based designs. This unanticipated result carried significant consequences on identifying the optimal temperature maintenance strategy.
