CO2 Heat Pump Water Heater Multifamily Retrofit: Elizabeth James House Seattle WA

May 2020

A Report for the BPA Emerging Technologies Initiative

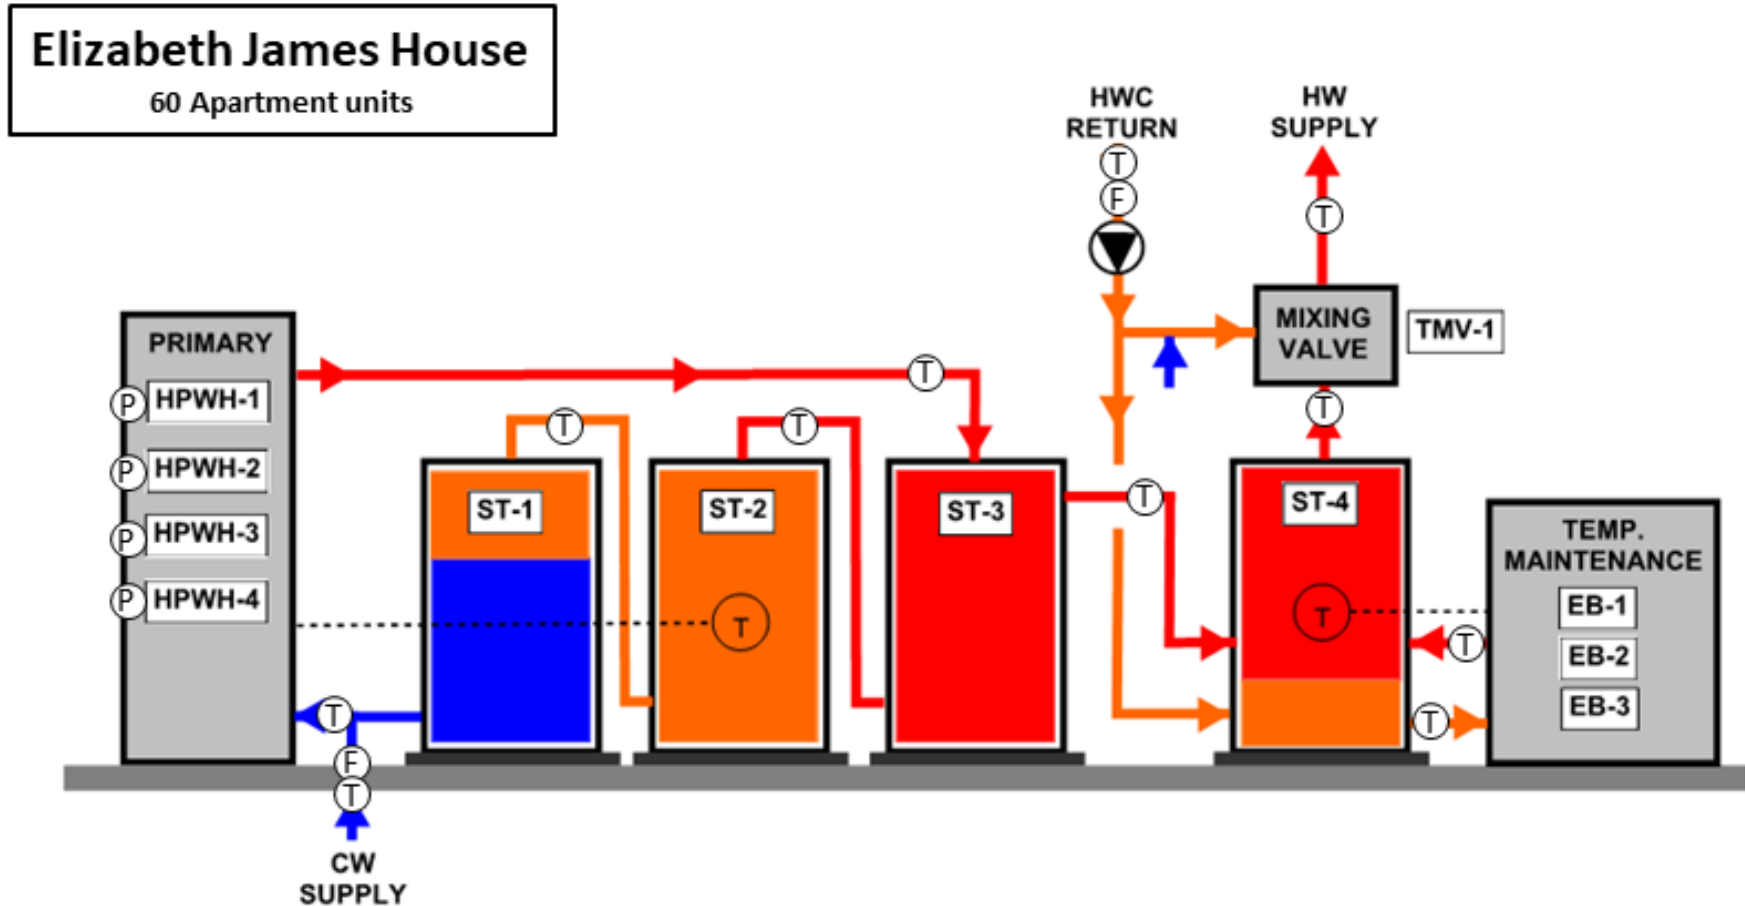
Figure 1. HPWH Plant Schematic and Monitoring Equipment Locations

Refer to the schematic diagram (Figure 1) for a simplified visual representation of the plant and locations of monitoring equipment. The narrative that follows explains the critical features central to the HPWH DHW plant design.

ⓕ Flow meter

Ⓣ Temperature sensor

---Ⓣ Temperature control point

Ⓟ Power meter. EB power for the boiler bank is calculated as the full panel power less the sum of the heat pumps.

- *Multiple Storage Tanks:* This design used multiple storage tanks plumbed in series. The arrangement enabled a high degree of temperature stratification throughout the system, with the hottest water at the end of the primary storage system (ST-3). It also used of smaller, less expensive tanks that were easier to install and fit through doorways. The three existing tanks were reused for the primary storage tanks. A fourth tank, ST-4, was added to act as a dedicated temperature maintenance tank (“swing tank”). This fourth tank is in series with the three primary tanks. See Figure 1.

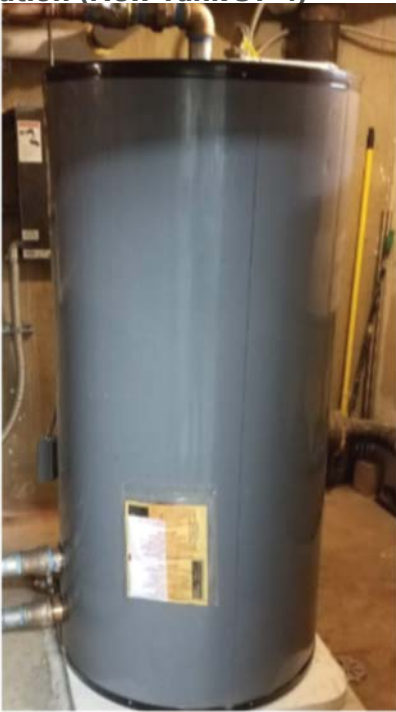
**Figure 3. Temperature Maintenance
DHW Storage Tank Before Pipe
Insulation (New Tank ST-4)**

- *Temperature Maintenance Swing Tank:* This tank (ST-4) was designed to swing in temperature between 120°F and 150°F. During periods with hot water use, over-heated (~149°F) water moves from the primary storage tank to the “swing tank”. These periodic draws keep the “swing tank” primed above 120°F. If the “swing tank” drops below 120°F the backup electric water heaters raised the temperature above 125°F.

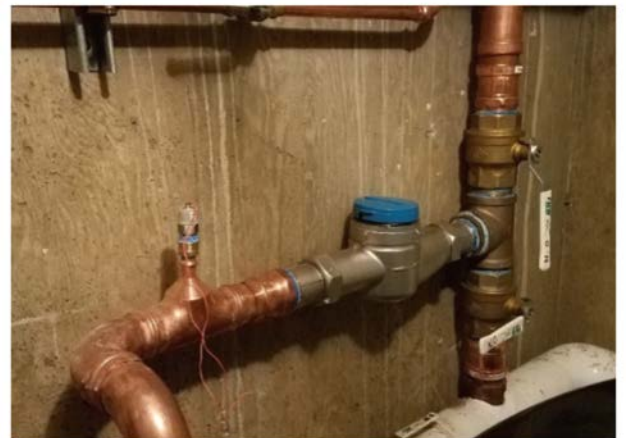
**Figure 6. Instantaneous Electric Water Heater
(Existing EB-1)**

- *Backup Electric Water Heaters:* This design used the three existing instantaneous electric water heaters for backup. Configured in parallel and operating in unison to deliver 135°F water to ST-4. The backup instantaneous electric water heaters operated any time the final storage tank dropped below 120°F either due to inadequate capacity coming from the HPWHs or due to extended periods of time with no hot water draws and continuous cooling from the recirculation system.

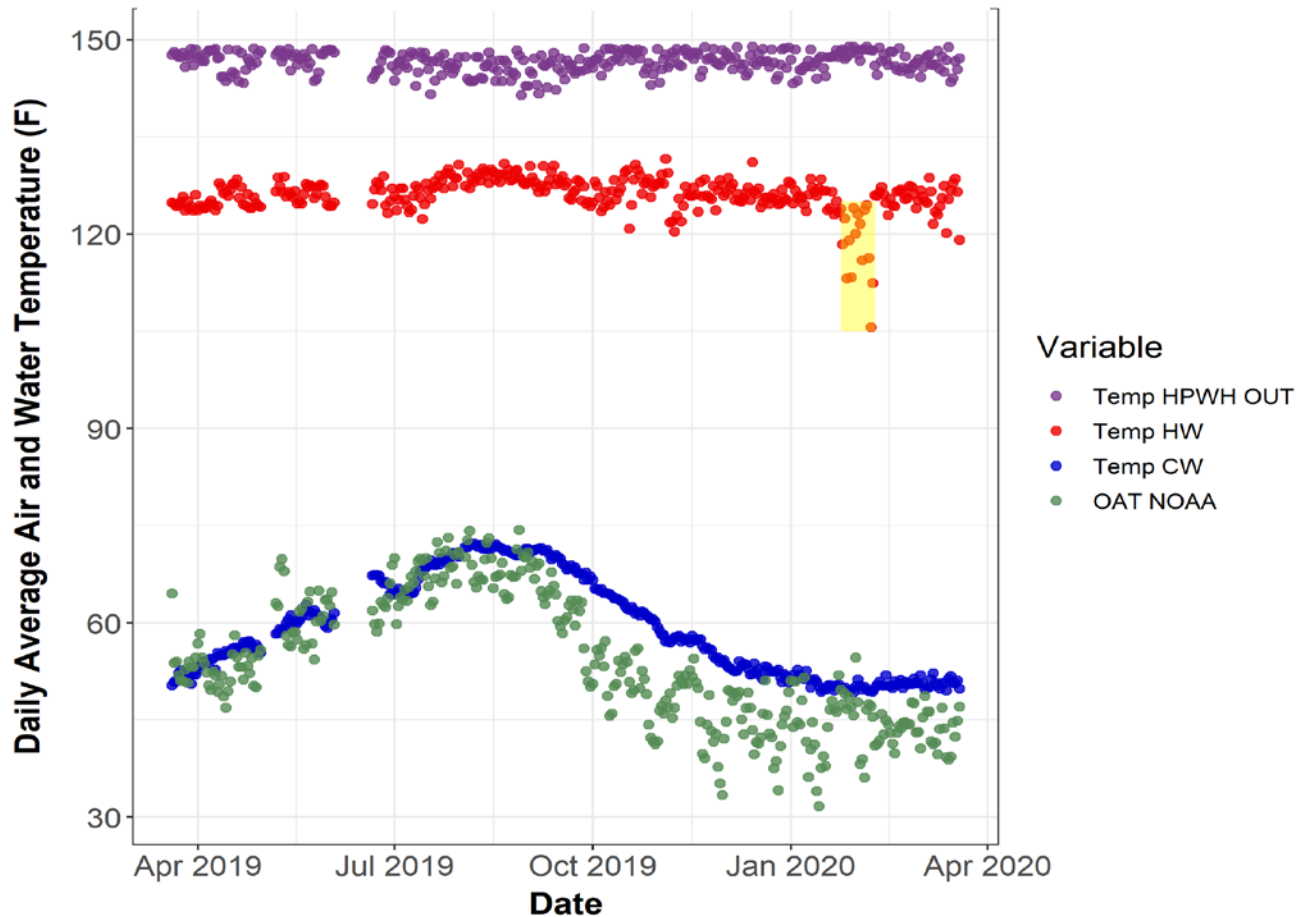
Figure 9. Daily Average Air and Water Temperatures

M&V data from March 20, 2019 through March 20, 2020 were used in this analysis. Figure 9 shows the water and air temperatures for M&V monitoring (excluding the leak event in June 2019). Collected M&V data show incoming (50-72°F) city water being heated to 147°F (even during periods when only three HPWHs were operable) and delivered to the recirculation loop at approximately 125°F. The dip in the delivered water temperatures in late January 2020 to early February 2020 corresponds with a time when multiple HPWHs were inoperable. Simultaneously, the backup electric boilers were not operating normally because of an inadvertent setpoint adjustment that compromised the flow sensors – these equipment issues were resolved in March-April 2020.

Leak event removed.
Yellow highlight shows period with < 4 operable HPWHs and back-up not functioning properly.

Temp HPWH OUT: Temperature of water leaving the HPWH bank and entering ST-3.

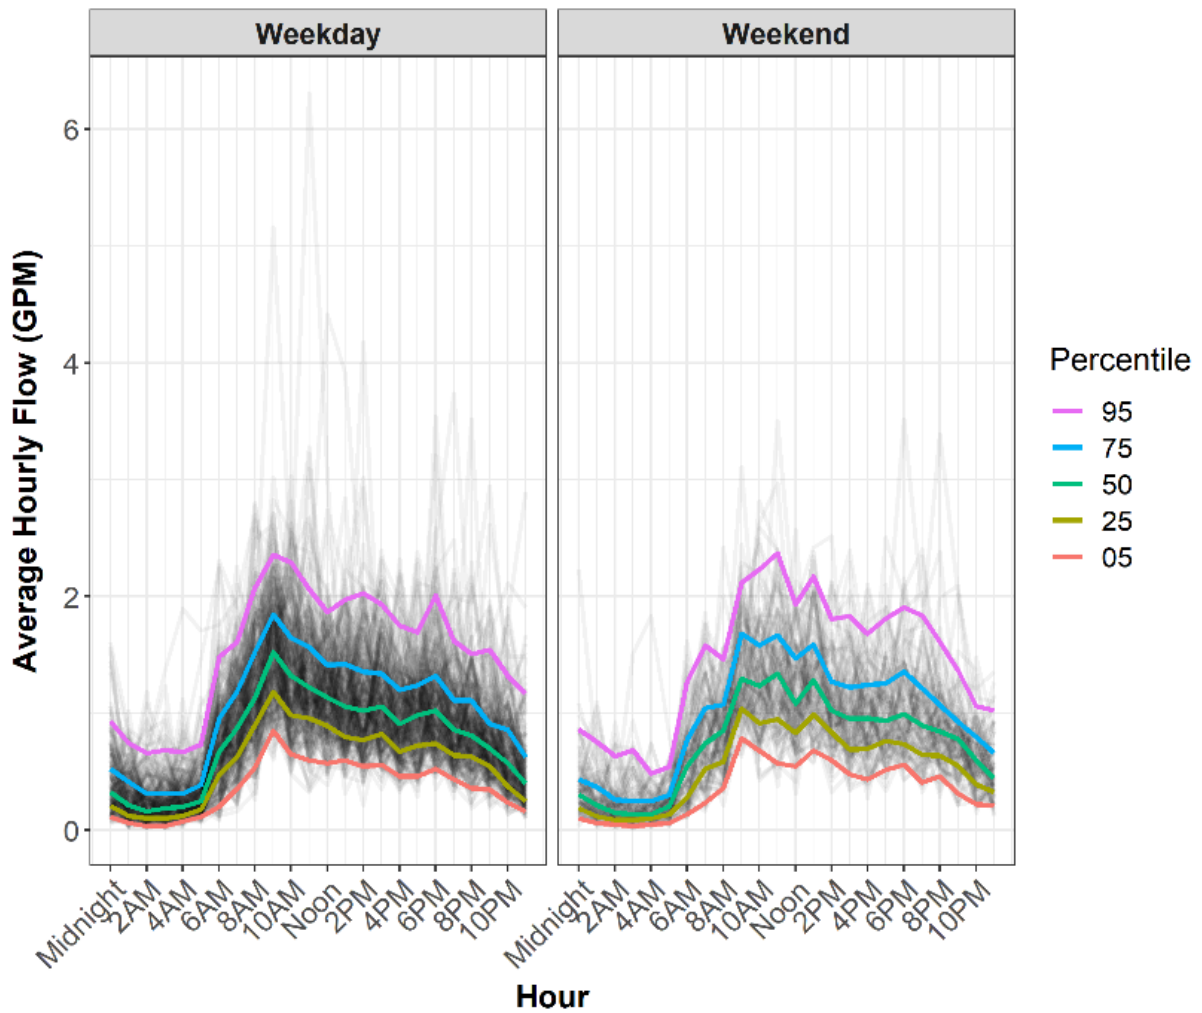
Figure 10. Average Water Use (GPM) by Hour of Day (Leak event removed)

Collected data included hot water use by building occupants' over the course of the project. Several interesting metrics are quantifiable through measured flow data. Figure 10 shows hourly average demand in gallons per minute (GPM) by the hour of the day, and by weekend or weekday. Individual days are shown in light gray. Colored lines indicate percentile of all data, with the middle green line (50%) being the median.

Overall, there is little difference between weekday and weekend use patterns. Both weekdays and weekends show higher 8-10am, and 6pm usage. Weekday and weekend as well as daily and hourly differences are less pronounced at the Site compared to other multifamily buildings. Multifamily buildings with working occupants typically have low mid-day usage on weekdays when occupants are at work, and weekend morning peaks may be shifted later in the day (Heller 2015). This is likely due to the senior demographic at Site.

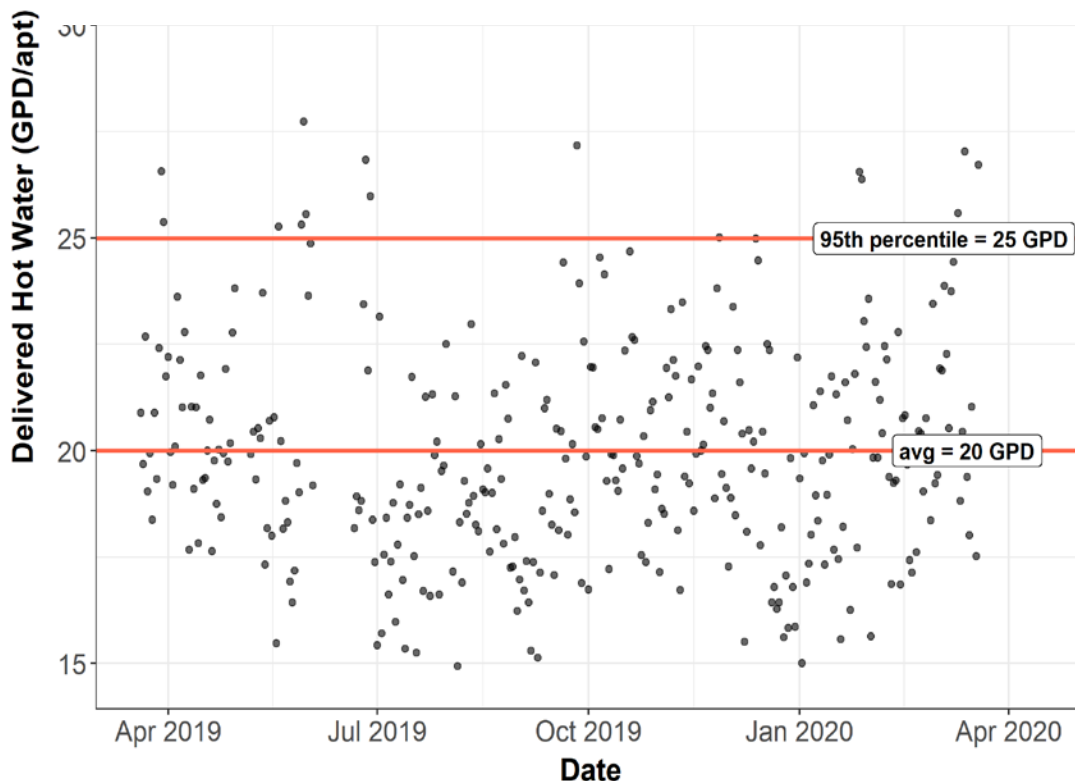
Figure 11. Daily Hot Water Used by Occupants (GPD/apartment)

Recorded flow data also demonstrated annual water usage at the Site. Much as inlet water and outside air temperatures show seasonal cycles, so does occupant water usage. Typically, water use is higher during cooler months and lower in warmer months. Regression analysis was used to estimate, daily delivered hot water for missing periods (approximately a week when the leak and repair resulted in inaccurate flow). With average daily temperatures for these periods, regression analyses were also used to predict a gallons per apartment unit metric, which was then included with measured data to calculate annual estimates.

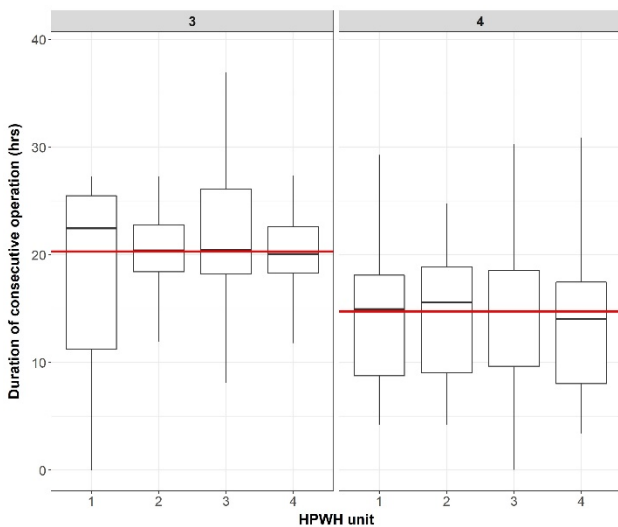
Figure 13. HPWH Run Times

The equipment manufacturer has recommended that systems should be designed so that equipment does not run for more than 16 hours per day. **Figure 13** shows that the equipment typically ran for approximately fifteen hours when all HPWHs were operable. Fewer functioning HPWHs led to longer run times of approximately twenty hours per day.

Ninety percent of the time, the heat pumps ran for less than twenty-four hours (whether there were three or four operable units). In the most extreme cases the HPWHs ran for several days consecutively. This was observed in late May 2019 as a leak was detected at the site and again in February 2020, when two HPWHs were inoperable, and the backup system not responding. At that time, the operable equipment ran for five days.

- Median run times with four operable heat pumps were 15 hours per day or a 63% duty cycle. This includes summer and winter periods representing the warmest and coldest ambient conditions. Fewer operable units resulted in longer median duty cycles (83% or

20-hours). In extreme cases, during a leak event and when multiple heat pumps were inoperable, run times could exceed 24-hours.

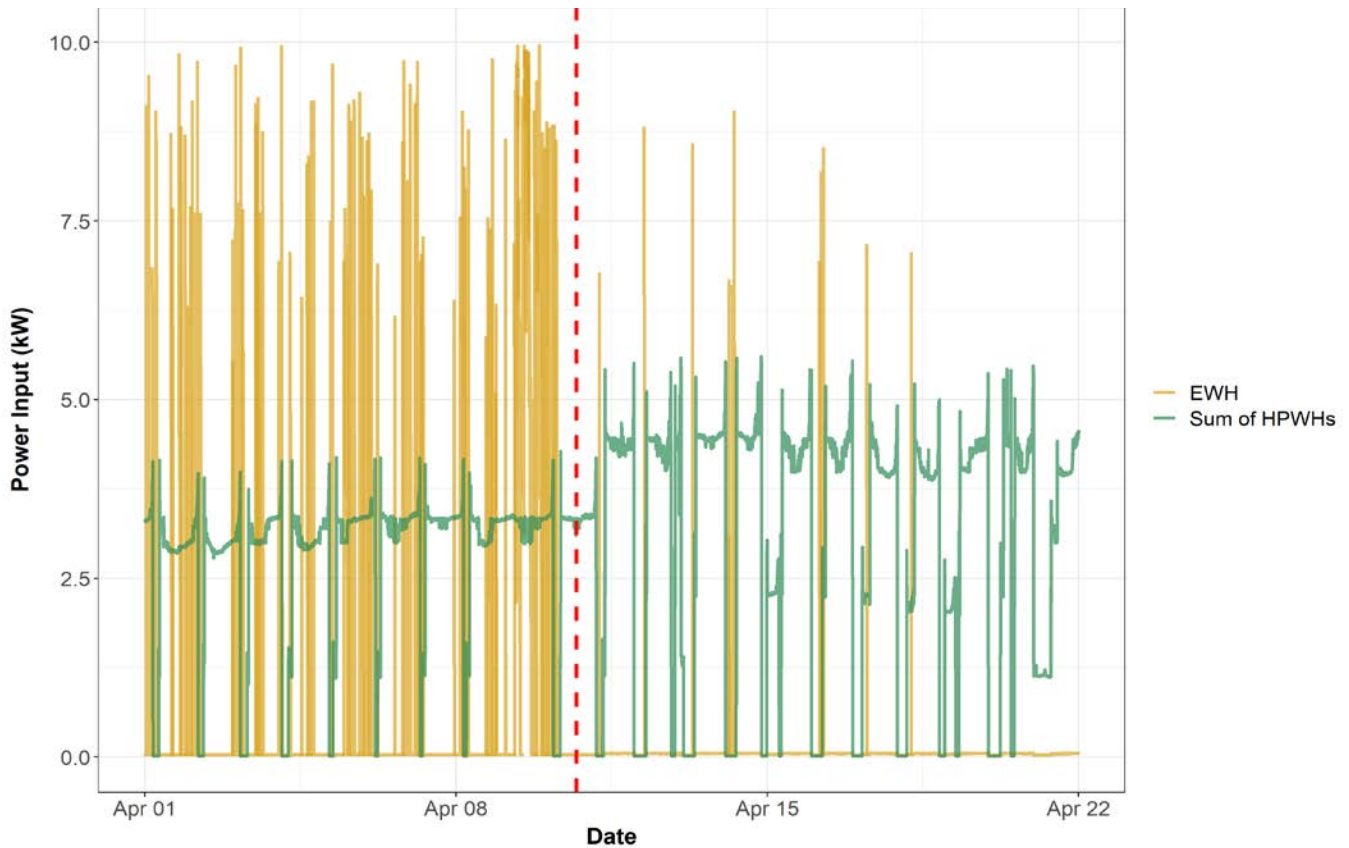
Figure 14. Redline Demarcating Power Input (kW) 3 vs 4 Operable HPWH

Although the majority of the HPWHs operated flawlessly during the monitoring period, occasionally, one or more HPWHs have been inoperable. The red line in **Figure 14** demarcates the ERWH usage during a period with three operable HPWHs (before April 11, 2019) and with four operable HPWHs (until April 22). With the HPWH equipment operating as designed (to the right of the red line) only minimal operation of the backup boiler equipment was observed.

Additionally, the “swing tank” is kept at a more stable temperature when all HPWHs are available. Periods when only three HPWHs were operable show lower temperatures and a greater variability in average daily temperatures of water leaving the “swing tank”. This is as expected as it would take longer for three HPWHs to recharge the

storage tanks with 150°F water, and the electric boilers are set to maintain recirculation loop temperatures (not the super-heated water provided by the HPWHs).
