Commercial Building Energy Code Compliance in Oregon

For Oregon Department of Energy
under contract #C91140

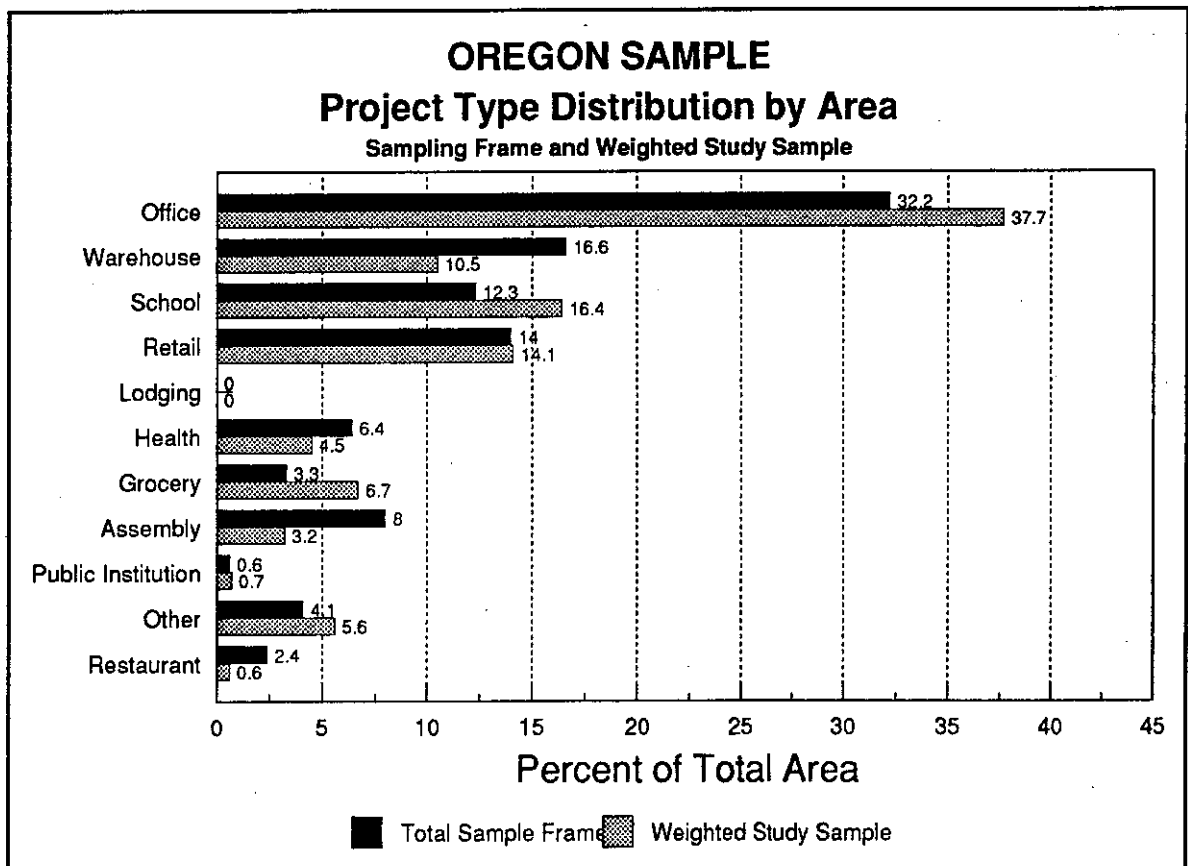
Figure 2.3 This figure illustrates the distribution of square footage by end use category for the total population and the final sample. The principal difference is explained by the over-sampling of large buildings which resulted in an increased percentage of square footage being assigned to schools and offices. But again the sample is reasonably consistent with the distribution of the square footage for the total population. This final sample was used to evaluate building characteristics and code compliance for Oregon.

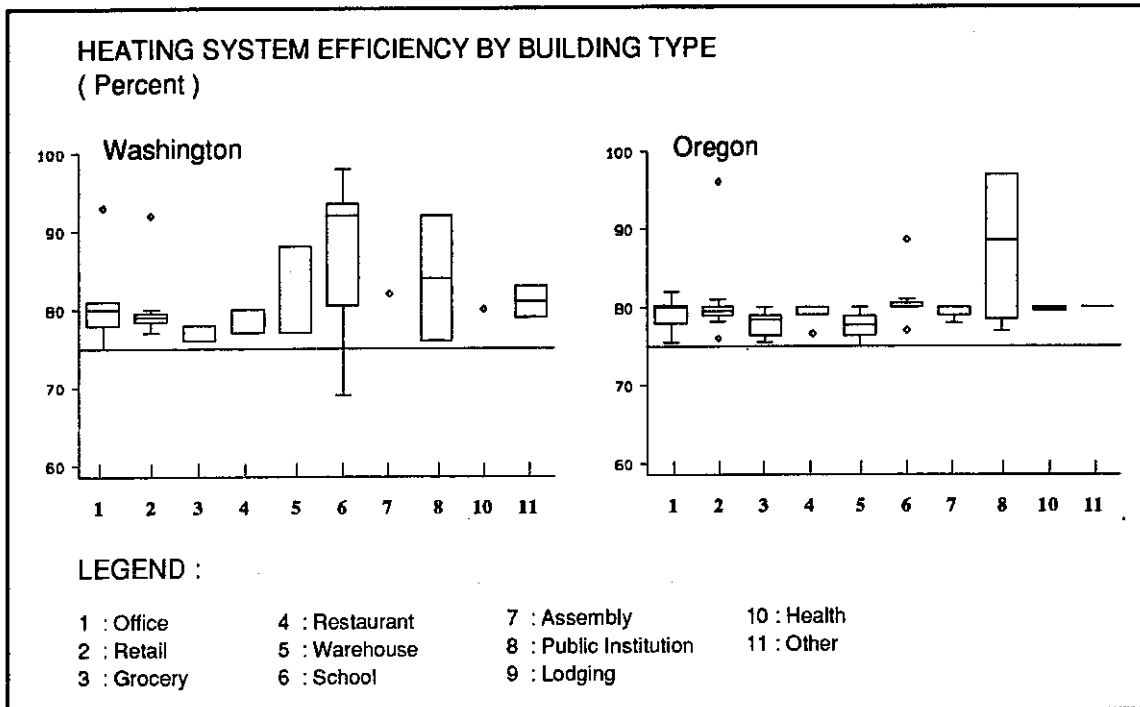
Figure 4.3
This figure compares the two states on heating system efficiency for fossil fueled devices. The Oregon sample has much less scatter than Washington but both are well above the average code requirements. We believe this is due to manufacturers developing more efficient equipment. Most of the more efficient equipment in Washington buildings is in schools, apparently a result of the state-mandated lifecycle cost purchasing process. The 75% efficiency line is included to provide a visual reference; code provisions vary from this standard.

Both states regulate equipment efficiency by setting a lower limit or floor on efficiency. Figure 4.3 shows how this affects code compliance. This is an ideal situation, showing how all code provisions should work.

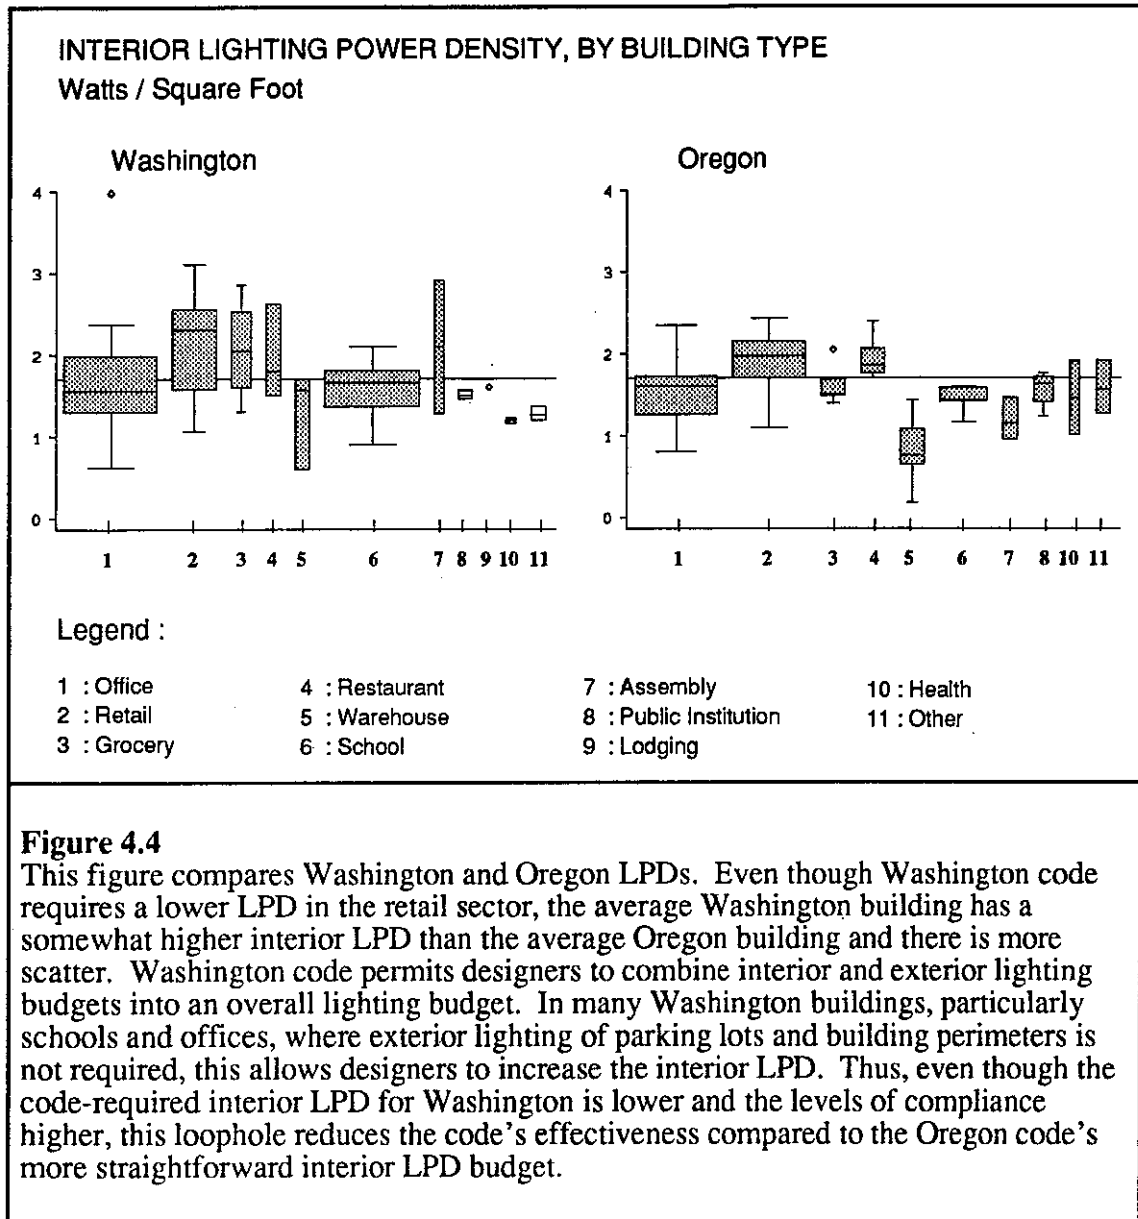
Figure 4.4

This figure compares Washington and Oregon LPDs. Even though Washington code requires a lower LPD in the retail sector, the average Washington building has a somewhat higher interior LPD than the average Oregon building and there is more scatter. Washington code permits designers to combine interior and exterior lighting budgets into an overall lighting budget. In many Washington buildings, particularly schools and offices, where exterior lighting of parking lots and building perimeters is not required, this allows designers to increase the interior LPD. Thus, even though the code-required interior LPD for Washington is lower and the levels of compliance higher, this loophole reduces the code's effectiveness compared to the Oregon code's more straightforward interior LPD budget.

As with the heat loss rate, the average building shows a 20% improvement over the code standard. This compares to the Washington sample in a way that illustrates the value of straightforward code provisions.
