# **Residential Energy Code Compliance in the State of Oregon**

**FINAL REPORT**

**September 30, 1994**

**Prepared for Oregon Department of Energy  
Under Contract No. C95030**

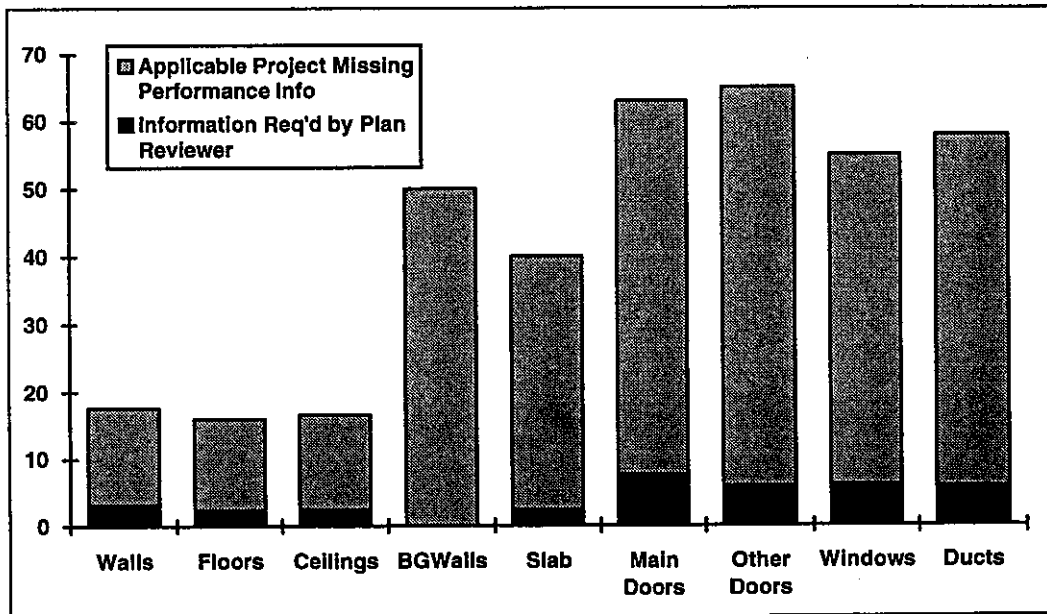
**Chart 3.2**  
**Documentation of Compliance of Components**

This chart indicates the percent of each component which failed to provide any information on the submittal about the component insulation level or performance (% of projects which included that component), and the frequency with which the plan reviewer requested or identified this information when it was missing.

The combination of energy information presented usually leads to an incomplete picture of energy code compliance from the perspective of plan review. In reviewing compliance documentation of submitted files, field technicians found that only 25% of the plans reviewed contained enough information to verify that the projects complied with the requirements of the energy code. This is not to say that the other 75% of the projects did not comply with the requirements of the code, merely that they did not demonstrate this compliance on the plans. Chart 3.2 indicates the percentage of projects which did not indicate insulation or performance levels for the components listed. This table also indicates how frequently this information was required by the plan reviewer in these cases, as evidenced by redlines or other corrections on the plans. Although the files did not include these clarifications we assumed that the "red lines" were meant to flag issues to be reviewed in the field.
